**Tri-State Home Inspections LLC**  
4235 Fairway St  
La Crosse WI 54601  
563-380-2515  
holm@tristateinspections.com

**Report:** 6299-skillian **Address:** S2873 Willow Ln

## **Confidential Inspection Report**

### **S2873 Willow Ln**

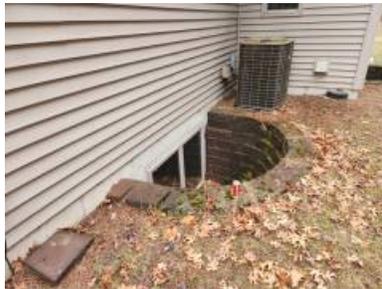
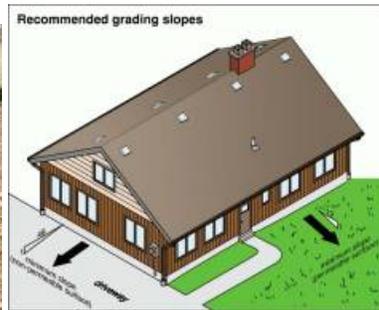
Window wells noted.

- Clean out the debris.

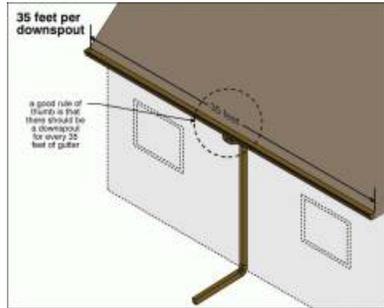
Gutters are an extremely important element in basement dampness control. Keep gutters clean and downspout extensions in place (6 or more). Paint the inside of galvanized gutters, which will extend the life. Shortly after a rain or thaw in winter, look for leaks at seams in the gutters. These can be re-caulked before they cause damage to fascia or soffit boards. If no gutters exist, it is

recommended that they be added. I recommend cleaning the gutters annually.

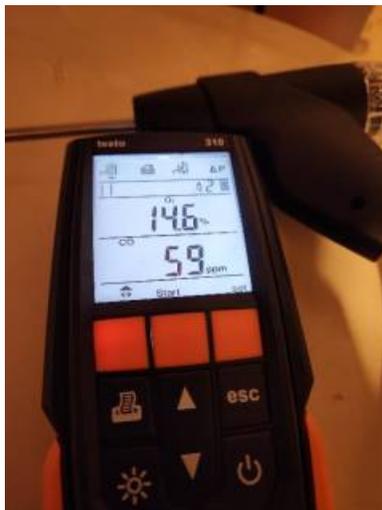
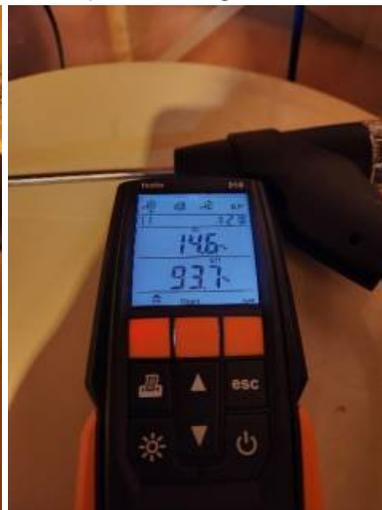
Combustion test results show the appliance is working within acceptable ranges.

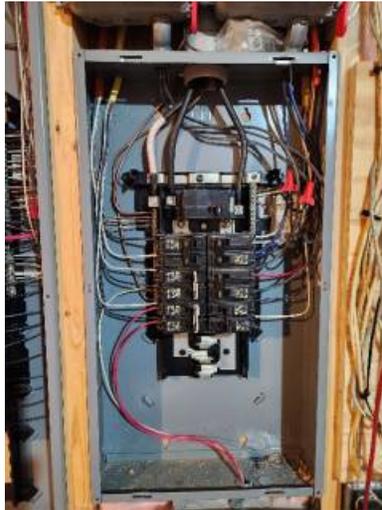
- The cover or dead front of the service panel was missing some screws. These should be replaced with proper-sized screws for secure

attachment.

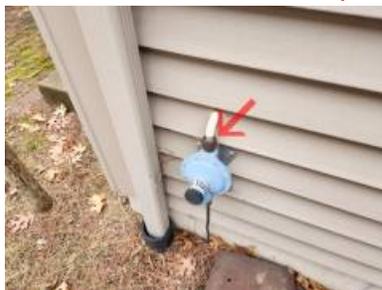
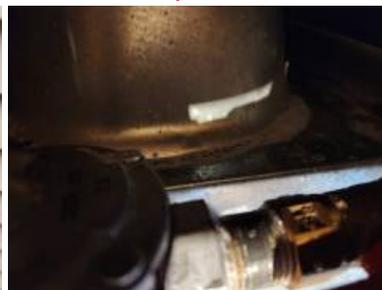
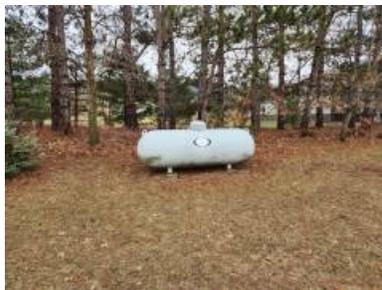
**Meter / Tank:**     LPG/Oil tank located, at the exterior  
**CSST gas line installed in the home, Ungrounded gas line noted, I recommend having the gas line grounded or bonded for safety, this is not a code inspection. Bonding is provided primarily to prevent a possible electric shock to people who come in contact with the gas piping and other metal objects connected to the grounding system. Nearby lightning strikes can also result in an electrical surge and can potentially puncture a hole in the CSST. Proper bonding and grounding will reduce the risk of damage and fire from a lightning strike.**

Action Necessary.

Gas detected with gas detector and soap bubbles near the interior pressure regulator. Any leak in the gas service supply lines should be considered serious Services of a qualified licensed plumber will be needed.

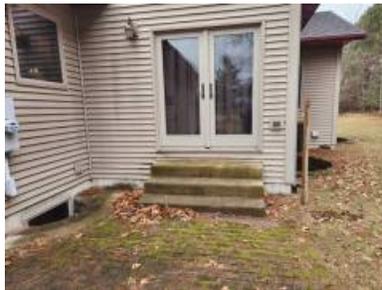
No landing or steps noted.  
The landing on both sides of an egress door must be at least as wide as the door it serves, extend at least 3-feet perpendicular to the door, and not be more than 1-1/2-inches below the top of the threshold. But the code does allow one exception: the landing or floor at the exterior side of an egress door can be as much as 7-3/4" below the top of the threshold.

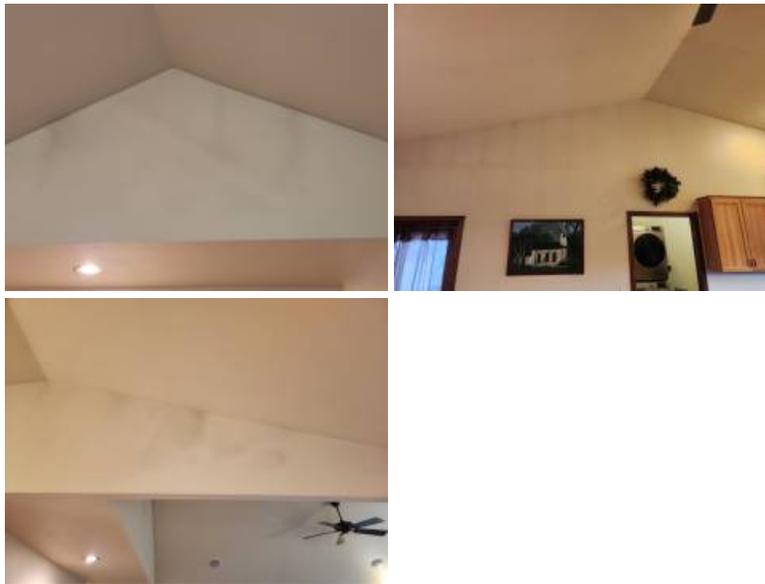
Ghosting is noted with the ceiling. Ghosting is caused by a thermal bridge using the rafter. The temperature difference causes condensation, where soot and dust sticks to the ceiling in these areas. The best defense is to add more insulation to prevent the thermal bridging.
