Mama T's Septic Service

Septic System Compliance Inspection – Existing System

Street Address: 18467 Vineland Rd

Parcel ID# or Sec/Twp/Range: 09-006-0200 Reason for Inspection Property Sale
Local regulatory authority info: Mille Lacs County
Property address: 18467 Vineland Rd, Onamia MN 56359
Owner/representative: Dale Fradette Owner's phone: 626-497-1738
Brief system description: 1600 Gallon combo tank; 10' x 50' mound

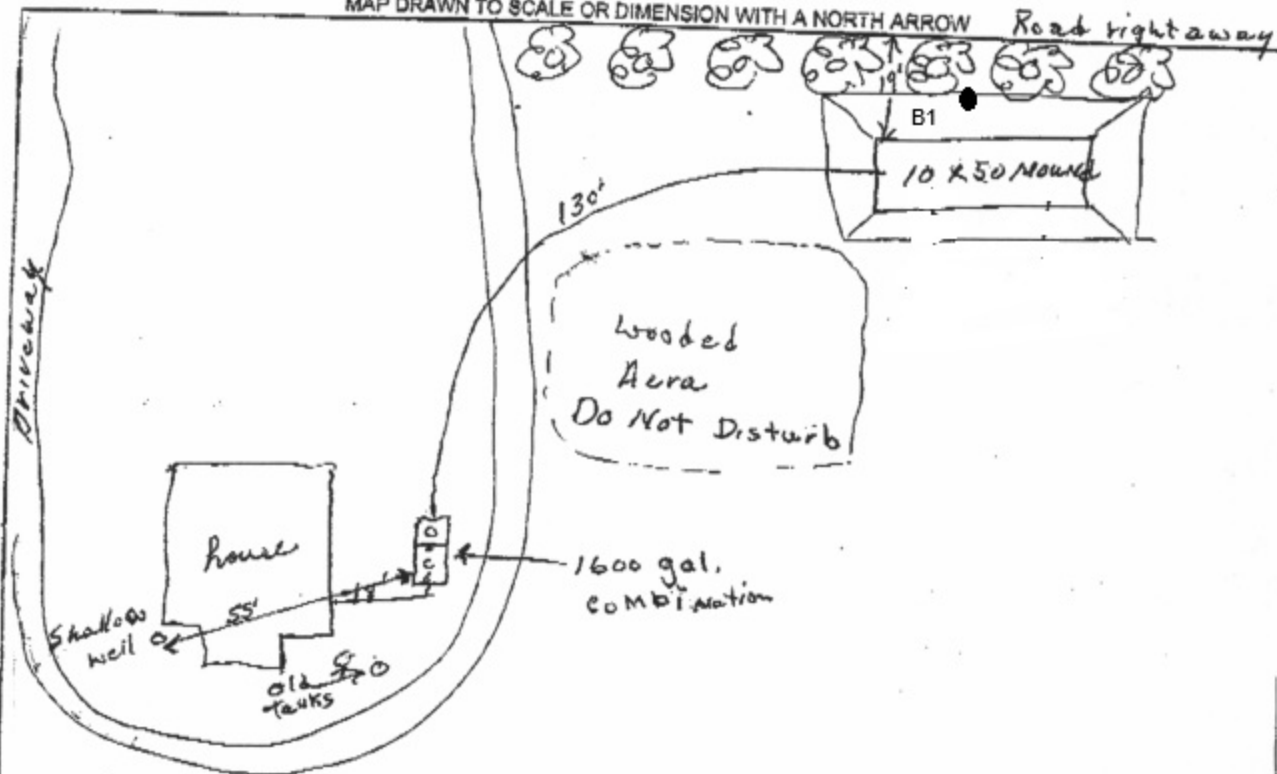
SKETCH SHEET

80 acres no other
Property Lines close to
Prairie Area
