# Property Inspection Report

**N5598 170th Ellsworth**  
**Inspection Prepared For: Ethan Sandstrom**  
**Year Built: 1890 Size: 3895**

**Date of Inspection: 6/2/2026 Weather: Sunny 75°**

**Best Choice Home Inspections**  
**Steve A Jennings 3380-106**  
**Jenningsinspections@gmail.com**

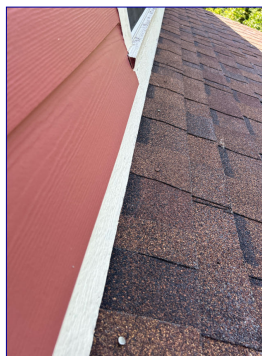
## 7. Condition of Roof Covering

• There are exposed nail heads on the roof. Exposed nail heads may allow water to seep through and damage the sheathing over time. Recommend a licensed roofer caulk the exposed nail heads.

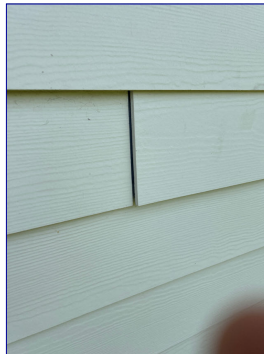
## 2. Siding

- Loose

- The siding was loose in one or more areas. Recommend a licensed contractor to repair the siding.

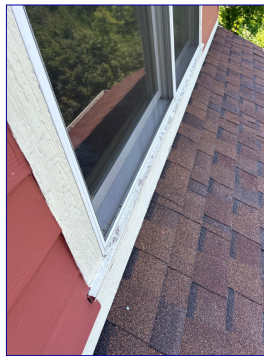
## 3. Trim

- The exterior trim was in need of normal painting maintenance. Recommend a professional painter repair/paint the exterior trim.

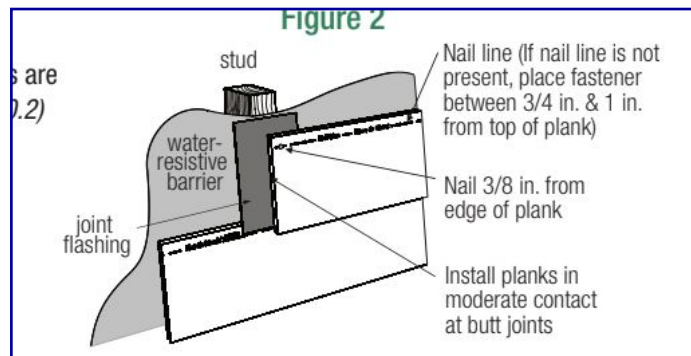
## 6. Flashing

- The exterior flashing needed repair in one or more areas. Recommend a licensed contractor repair to prevent additional damage.

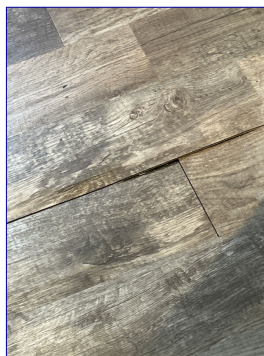
- Basement floor was covered in one or more areas and was not visible. It is always possible that hidden damage may exist in non-visible areas. Consult a licensed contractor as needed.
- The basement floor was damage near the steps. Repair/replace as needed.

This was at the bottom of the steps. Repair and replace as needed.
