**Tri-State Home Inspections LLC**  
4235 Fairway St  
La Crosse WI 54601  
563-380-2515  
holm@tristateinspections.com

**Report:** 6299-skillian **Address:** S2873 Willow Ln

## **Confidential Inspection Report**

### **S2873 Willow Ln**

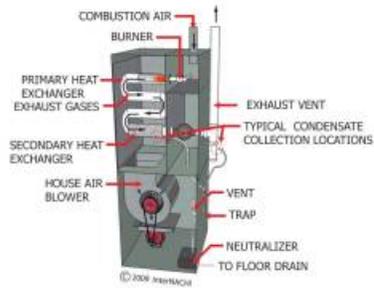
CONDENSATION IN A HIGH-EFFICIENCY FURNACE

**Fuel Source:** Propane, Electronic ignition is provided.

**Capacity / Approx. Age:** Btu Size: 100,000 Btu installed in 2004.  
The typical service life for a forced air gas furnace is 18 - 20 years.

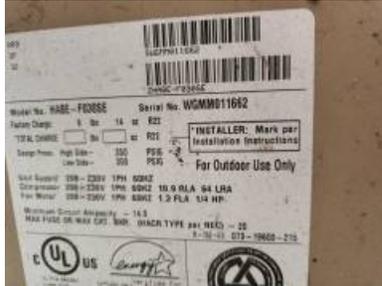
**Fuel Source:** 220 Volt, Electrical disconnect present.

**Capacity / Approx. Age:** BTU Size - 2 1/2 ton unit, Installed in 2004, The typical service life for a forced a central air conditioner is 18 - 20 years.

**System Condition:**     For optimum performance, the air conditioning system should be serviced annually prior to the cooling season. It is recommended that the filter(s) be changed or cleaned every 30 to 45 days for best performance.

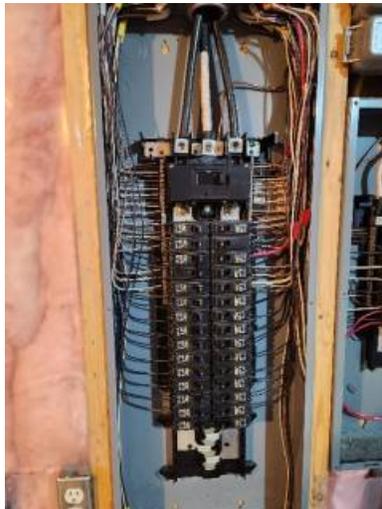
**Main Panel Observations:** Service amps: 200 amp, Circuit and wire sizing correct so far as visible, Grounding system is present.

**Heat Panel Observations:** Service amps: 100 amp, Circuit and wire sizing correct so far as visible, Grounding system is present

- The cover or dead front of the service panel was missing some screws. These should be replaced with proper-sized screws for secure

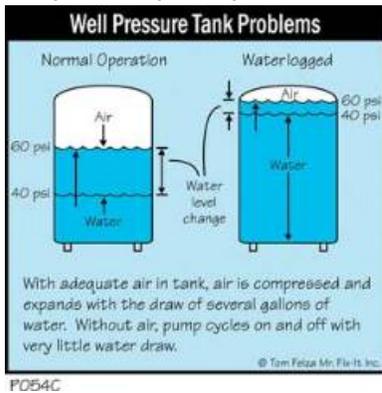
Pressure tank located in the home.  
 How does a pressure tank work, as water is pumped from the well into the pressure tank, it compresses the air in the tank until it reaches a preset level, typically the 40 to 60 pounds per square inch (psi). Water pressure from 40 to 80 pounds per square inch is considered within normal/acceptable range.

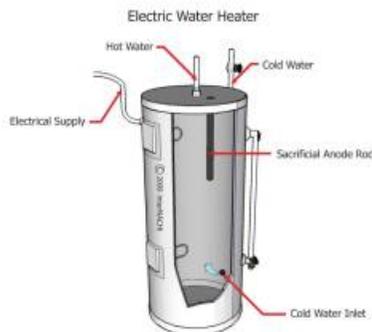
The temperature pressure relief valve at the upper portion of the water heater is a required safety valve which should be connected to a drain line of proper size terminating just above floor elevation. If no drain is located in the floor a catch pan should be installed with a drain extending to a safe location. The steam caused by a blow-off can cause scalding. Improper installations should be corrected.

**Power Source:** Electric, Satisfactory - The electric service to the water heater appears to be installed in an acceptable manner.

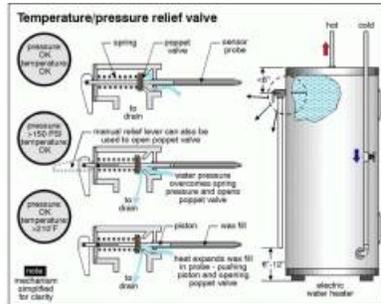
**Condition:**     Appears serviceable, Pressure relief valve noted, not tested.  
Installed: 2004.

Water heaters have an average 10-12 year life span and usually rusts from the inside out. I recommend to annually flush the water heater to maintain the efficiency of your unit and ensure the highest water quality for you and your family.
